SOUTH FORK CLEARWATER RIVER HABITAT ENHANCEMENT
NEZ PERCE NATIONAL FOREST

Project Number 84-5
Contract Number **DE-AI79-84BP16475**

April, 1992

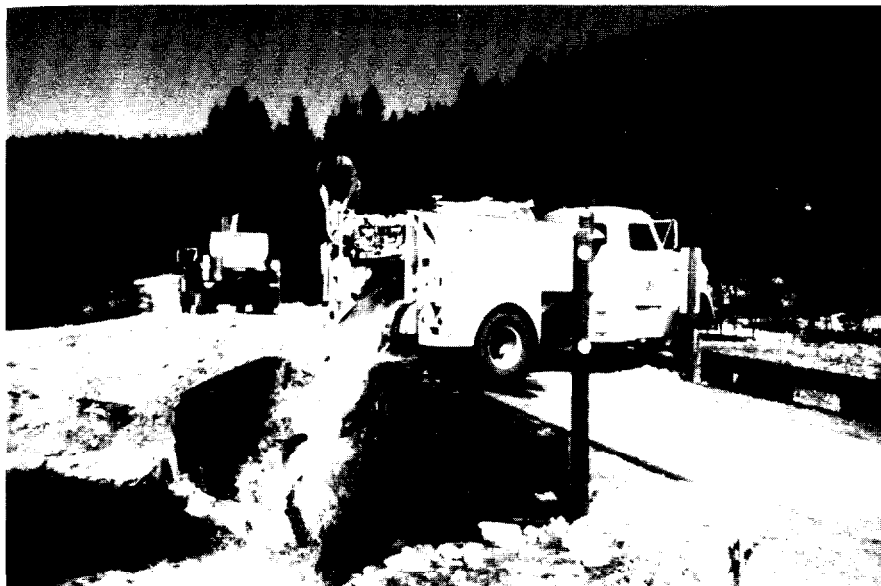
Figure 6. Idaho Dept. of Fish and Game releasing adult steelhead into Crooked River from newly constructed bridge on County Road 233.

One of the first activities of the project was to replace the culvert at milepost 8.2 on the Crooked River Road (County Road 233). Original plans called for the installation of a pipe arch, but subsequent examination revealed that building a bridge would result in less damage to the channel and existing fisheries habitat. USFS engineers surveyed the area, designed the new bridge, and oversaw its construction in 1984 (Figure 6).

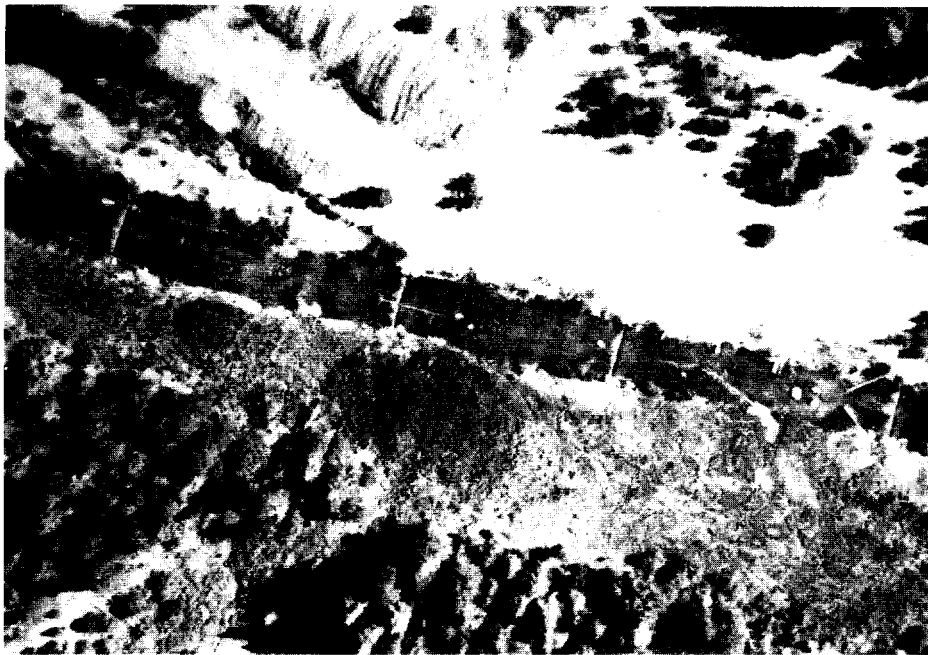
Figure 7. Detail of Project Segment II showing a series of structures, Crooked River, 1986.

Instream structures were constructed to provide cover, spawning habitat, winter rearing habitat and structural diversity. A total of 34 log weirs, 96 rock and boulder weirs, one Hewitt ramp, 70 deflectors, 240 boulders (singly and in complexes) and 238 pieces of large woody debris were installed in Crooked River during the course of Project 84-5 (Table 1). Most of the structures were installed in Segments I and II, where diversity in the habitat was lacking. In long, straight, homogeneous reaches of the river, structures were placed in groups, so that they would act upon each other (Figure 7). In late 1984, after 18 log weirs, 31 boulder weirs and 19 deflectors were installed in Segments I and II, a cursory survey revealed a continuing lack of cover. In 1985 crews returned to Segments I and II and used nearby conifers to add additional cover. In Segment IV, which already had a high pool:riffle ratio, emphasis was placed on adding cover to existing habitat types

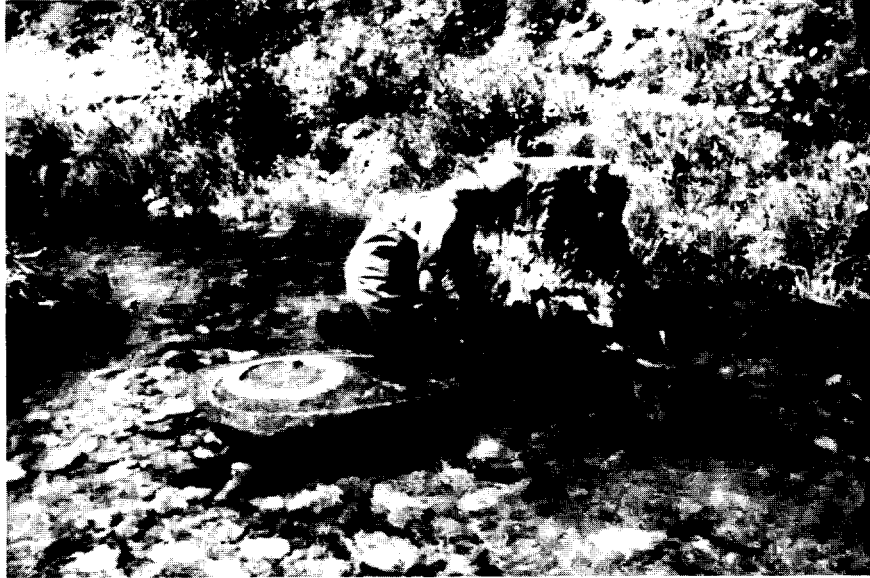
Figure 8. Securing a rootmass with cable, Crooked River, 1986.

Construction Methods: In general, installation of the structures required a hydraulic excavator. Individual elements of the structures were secured to bedrock or existing boulders with three-eighths to one-half inch galvanized cable (Figure 8). The cable was fastened using a gas-powered rock hammer drill manufactured by Hilti, and Hilti's C100 bonding material. Much of the work, like placing filter cloth and wire mesh, was completed by hand (Figure 9). Actual installation methods varied according to the conditions. For instance, in some cases, the fill behind a log weir was supported by 2 X 2 inch wire mesh and filter cloth, while in others fill material was placed behind the logs without additional support. Boulder weirs were constructed in both an upstream V and a downstream V configuration. Cover logs were sometimes placed parallel to the flow and sometimes at an angle to it, sometimes cabled and sometimes buried in the bank. Some of the boulder structures were created with existing material, and some with granite boulders brought from other locations,

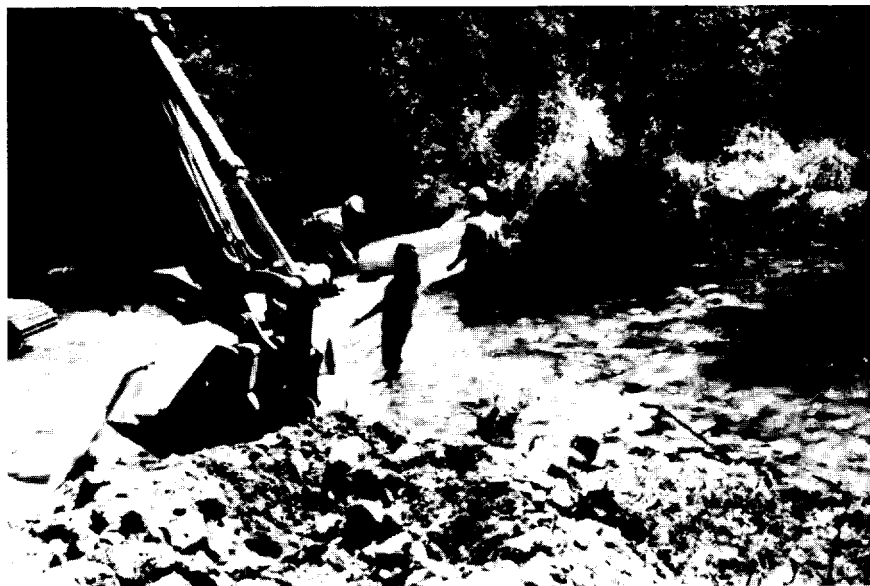
Figure 9. Constructing a log weir, Crooked River, 1985.

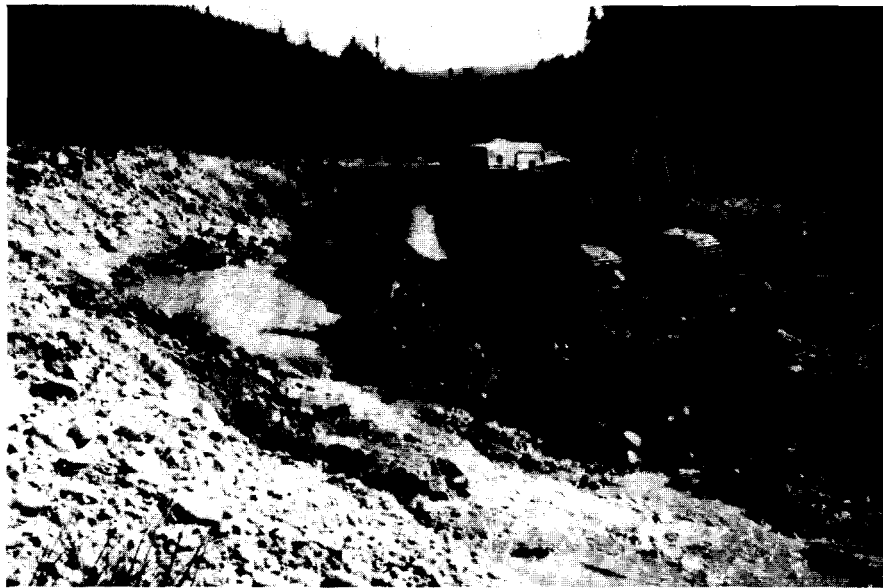
Figure 12. Pond connection. Project Segment I, Crooked River. 1987.

Construction Methods: A hydraulic excavator was used to dig the channels, while finishing work, like placing rip rap, planting and installing small weirs, was conducted by hand (Figure 12). Whether or not a pond was connected to the main channel at both ends, or only at the lower end, depended upon the individual characteristics of the pond. In some, water continues to enter through subsurface routes, but now drains through constructed outlet channels. In others, half weirs or partial rock berms were constructed in Crooked River in such a way as to encourage flow into the ponds. Culverts were installed at the head of a number of pond intake channels to provide a constant flow while preventing Crooked River from rechannelizing through the newly connected ponds. In several cases, especially those where channels were excavated perpendicular to the slope, water tended to seek previously established subsurface routes instead of following the new channel. Likewise, water in several of the ponds continued to drain through subsurface routes rather than follow the connecting channels.

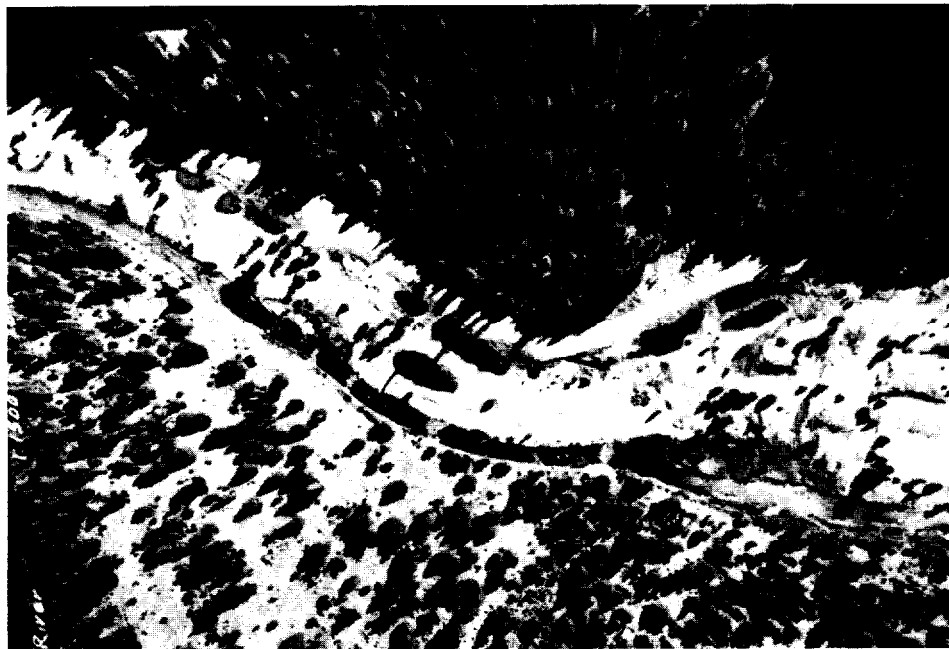
Figure 13. A series of ponds connected with side channels in 1986. and a side channel created in 1986 (left edge of picture). Project Segment II, Crooked River.

USFS personnel observed that in several ponds in Segment IV, smolts were actually trapped in dredge ponds when their subsurface entrance routes dried in mid-summer. Over 2,600 meters of side channel were constructed adjacent to Crooked River, mostly to ensure year-round access to existing dredge ponds. The side channels and the ponds increase the quantity of juvenile rearing and wintering habitat by some 15,000 square meters.

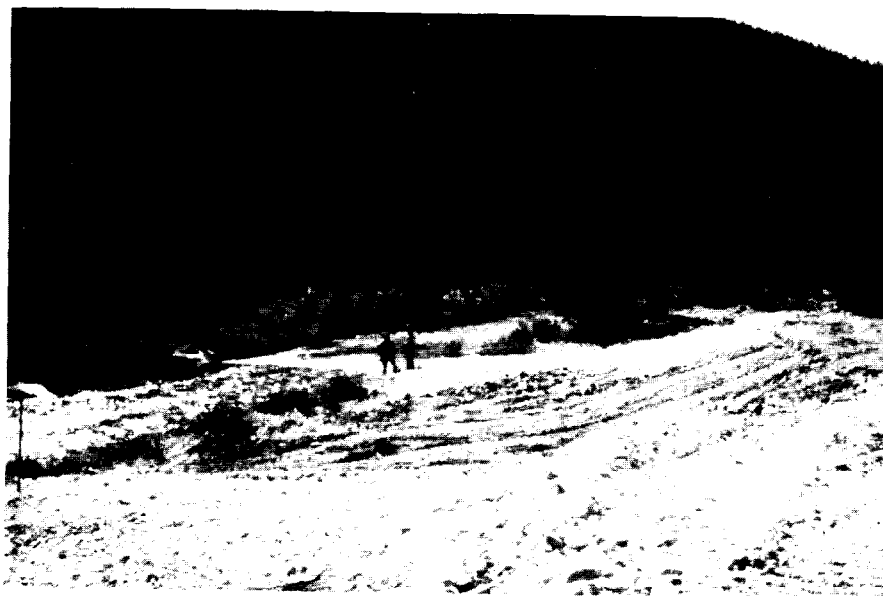
Figure 15. Newly created flood plain in Project Segment II, 1986.

In several places where dredge tailings had unnaturally constrained the channel, a hydraulic excavator and dumptruck, or in other cases, a D-6 cat, were used to remove enough of the tailings material to create a flood plain. Between 1985 and 1989, over 9,000 square meters of flood plain were constructed, mostly in Project Segments II and III. The flood plains were designed to allow yearly overflow at times of high runoff (Figure 14). In most cases, erosion control matting was placed on the flood plain to help collect silt from the overflow. In some cases, fine organic material and silt were excavated from nearby ponds and deposited on the flood plains to serve as growing medium. Large cobble and boulders uncovered during flood plain construction were often returned to Crooked River, creating interstitial space to increase habitat diversity and winter habitat. The new flood plains were seeded, fertilized and mulched (Figures 15 and 16).

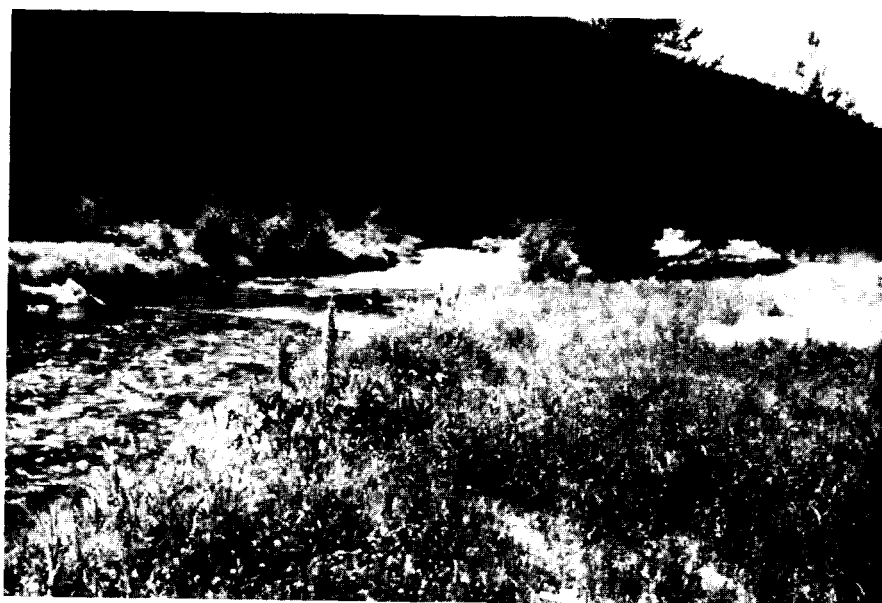
Figure 16. Same flood plain, one year after seeding.

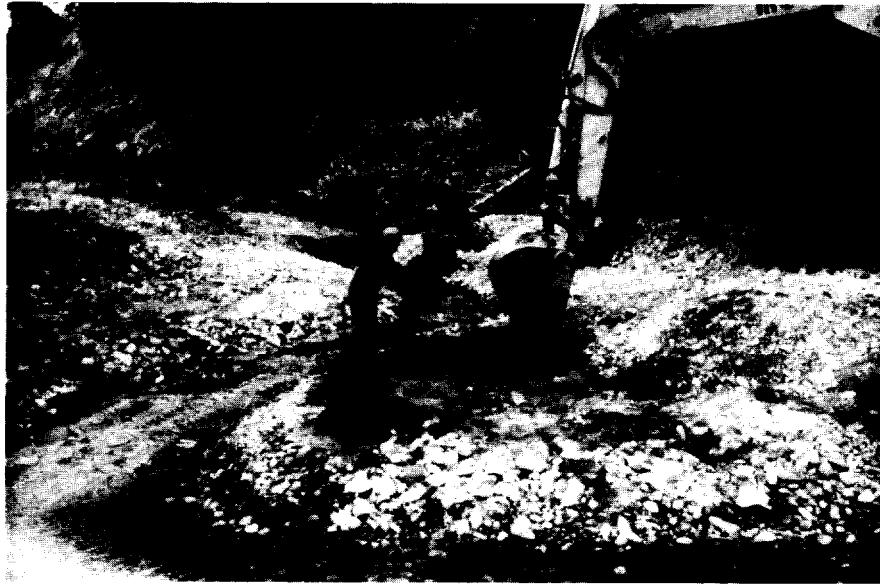
Figure 18. Clump planting in progress.

Clump planting of native alder and willow was fairly successful. Survival would have been higher had the planting occurred in early spring or late fall, rather than during the hot, dry summer period. It is felt that planting of shrub complexes has a great deal of potential, and project biologists recommend continuing the practice, as long as the plantings are made at an appropriate time of year.

Clump Planting (Shrubs): Approximately 130 "clumps" of shrubs were also planted in rehabilitated areas. An excavator was used to dig holes in the dredge tailings, and transplant whole "clumps" of shrubbery into them (Figure 18).

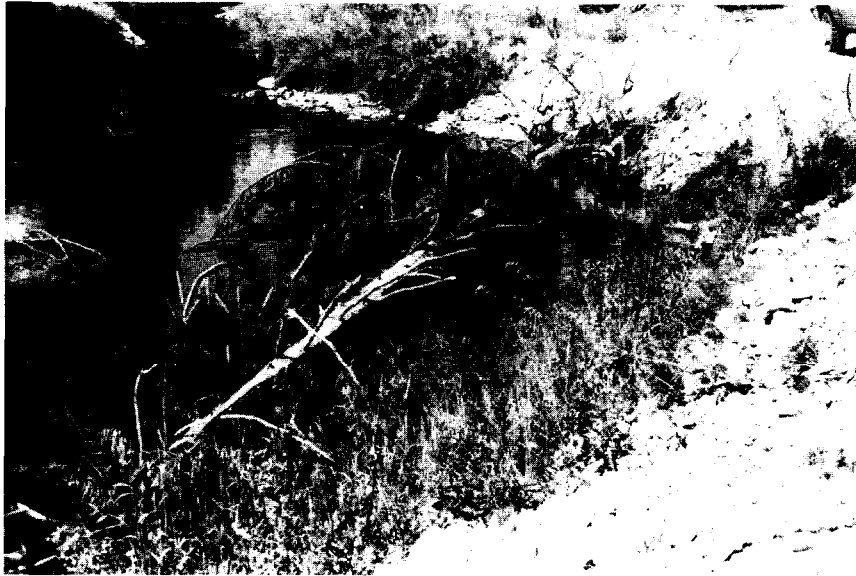
Structure success varied according to structure type and placement. Some of the structures performed as expected, and now provide quality resting and wintering habitat for adult and juvenile salmonids (Figure 22). USFS personnel have observed that the deep, created pools are heavily used by adult chinook (Moroz, pers. comm.), and that adults also frequently rest behind the boulders placed in pools in Reach IV.

Figure 22. Large woody debris installed for cover.

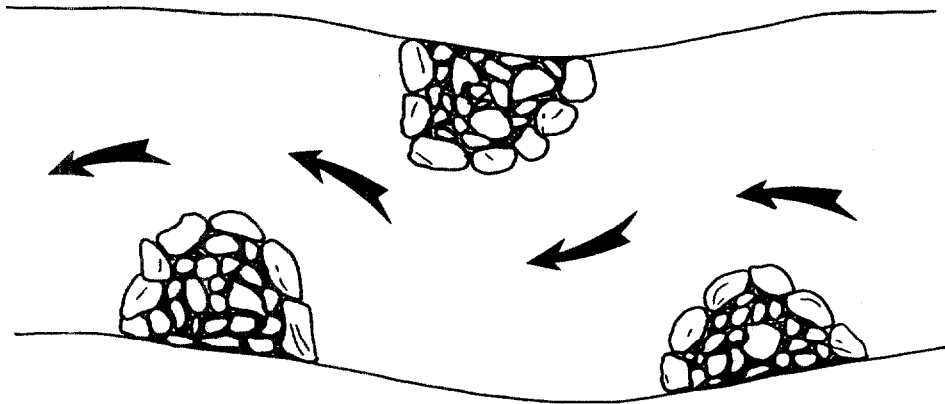
An example of this kind of approach is a series of low wing deflectors alternating on opposite banks (Figure 23). Water flow, constricted by the deflectors, scours a long trench pool of considerable value as fish habitat, without reducing the stream's ability to flush sediment from the system. Four of these series were constructed in Reach II in 1986. All four now provide quality habitat in areas that were formerly composed of homogeneous riffle/run sequences.

Figure 23. Alternating wing deflectors creating a natural meander and trench pool.

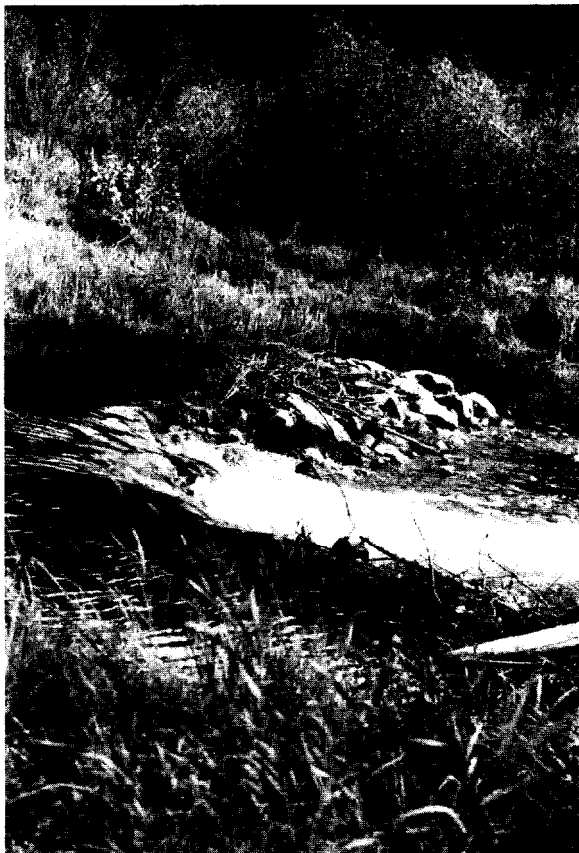
Where this many structures are installed, it is not unexpected that a few should fail or require some reconstruction. Many of the Red River structure failures were due to factors similar to those that caused Crooked River structure failure. The filter cloth backing in several log weirs tore, so that water flowed underneath, instead of over, the logs. One weir had been placed at a slight angle to the flow, and water had been forced into the bank on one side. As in Crooked River, several of the downstream V weirs were found to force water off the V sides, and into the banks below the structure. Several weirs had been located where banks were too shallow to prevent water from flowing around the structures and eroding bank material.

Figure 24. Upstream V weir.

Some maintenance work has been completed. Four downstream V weirs were changed to upstream V weirs in 1991 (Figure 24), and several inappropriately located structures were removed, and the banks reshaped and seeded.

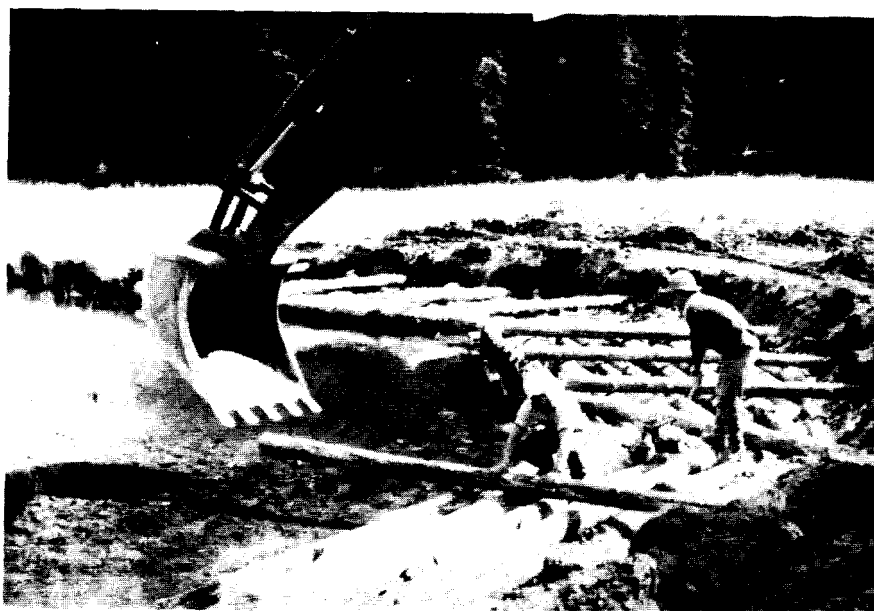
Figure 27. Construction of a cover sill structure in Reach I, 1988.

The cover sill structures have indeed reduced sediment input to the river from the accelerated retreat of .9 to 1.5 meter banks. However, a number of them were built at lower than bankfull stage, so that high flows annually overtop them, and erode the lowest part of the filled bank material. This fact reinforces the need to identify bankfull elevations and to design structures accordingly, especially those receiving the impact of turbulent flows on the outsides of meander bends. A few of the structures were not extended far enough down the bend, so that the locus of erosion has shifted downstream. In addition, because topsoil was not salvaged and redistributed, revegetation has been slow. Stock trampling and browsing also damaged those structures that were not fenced, or were fenced inadequately. While the problems have not rendered the structures ineffective, some reconstruction and topsoiling to promote quicker establishment of deep-rooted shrubs is required. This work, along with some additional required fencing, will be completed in 1992, as funding permits.

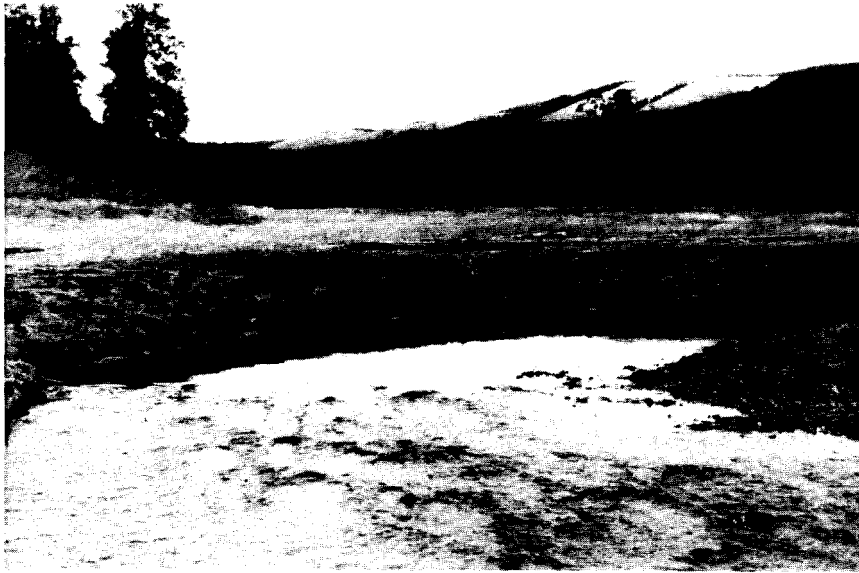
Figure 28. Shortly after construction of a cover sill structure in Reach I, 1988.

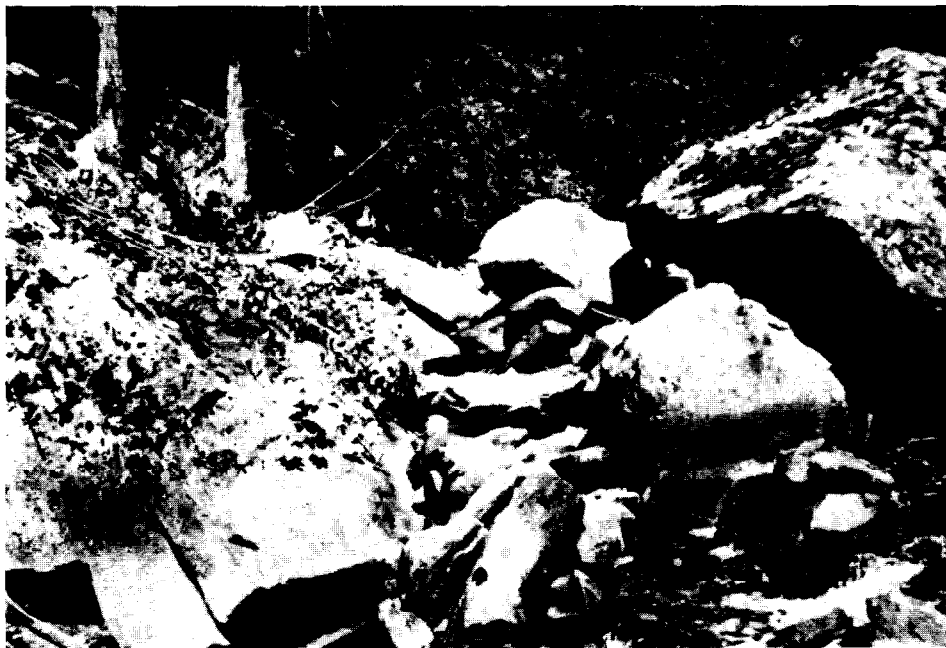
Figure 31. Meadow Creek project site before project work, 1986.

Results and Discussion: The project was completed in about four weeks in September of 1986, roughly half the time it was originally estimated to take (Figures 31 and 32). Annual maintenance involves cleaning the take-off pools and correcting any leaks under or around the log structures, and requires one to three days.

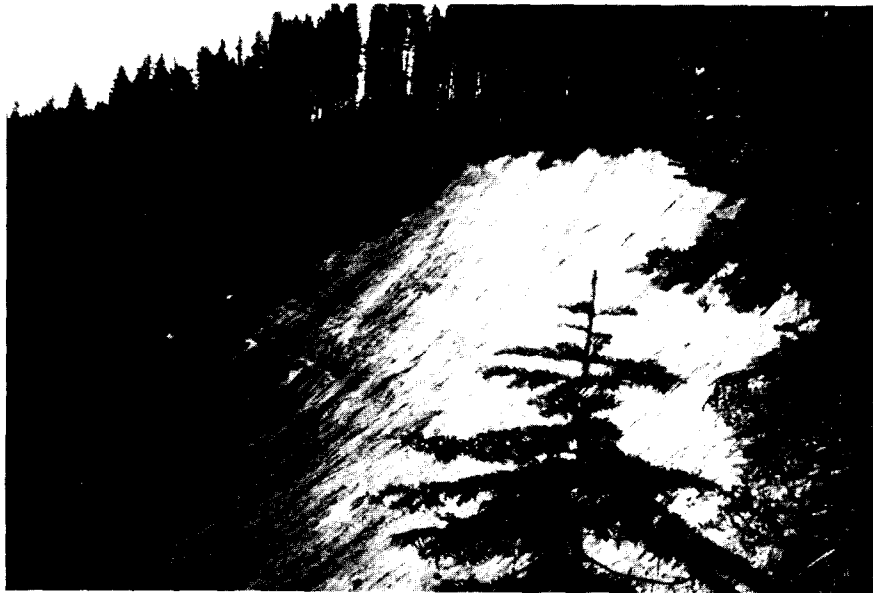
Historical Background: While the **Haysfork** Placer was locally known by its current name (Kennedy and Morgan, pers. comm.), it was evidently also called variations of "the Old Montana." Early reports contain no mention of a "Haysfork" mine or placer, but Bell (1908), Shenon and Reed (1934), and Reed (1934) refer to a mine they call "the Old Montana Placers," "the Montana," or "the Old Montana" that corresponds in location and magnitude to the **Haysfork** Gloryhole. In 1909, the mine was operated with four "giants" (nozzles), and appeared to be one of the most significant deposits in the district (Bell, 1909). According to Shenon and Reed (1934), between 459,000 and 612,000 cubic meters of interbedded gravel, sandstone and clay were removed from the placer between 1905 and 1915, yielding 317 ounces of gold and 29 ounces of silver. Water was brought to the site over Little Baldy Saddle from Pilot Creek: remains of the diversion ditch can still be seen from the Elk City Wagon Road (Morrow, pers. comm.). Sluice boxes emptied tailings directly into **Newsome** Creek after processing. Until 1984, upper slopes of the pit were much as the miners had left them in 1915, although massive erosion had undoubtedly occurred since then. The upper scarp, at 100 percent slope, was being undercut by wind and rain (Figure 36).

Figure 36. Upper slopes of Haysfork Gloryhole. prior to project work in 1964.

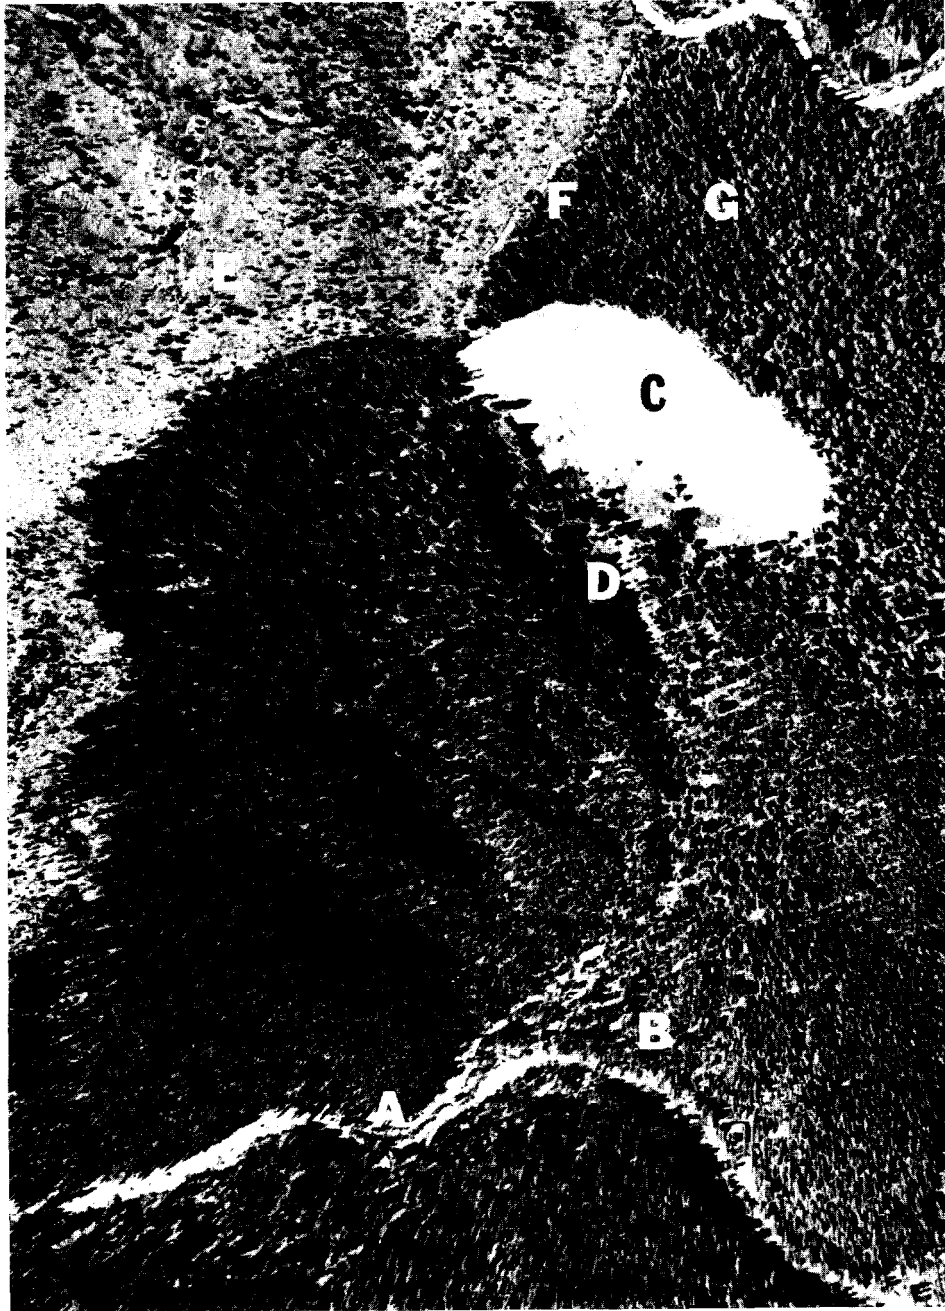
Figure 38. An aerial view of Haysfork Gloryhole, 1989. A. Site of sediment traps. B. Site where sediment removed from traps was dumped, 1991. C. Bench in gloryhole face, constructed in 1984. D. Site of check dams constructed in 1984 and 1985. E. Area clear cut in 1966 or 1967. F. Steep skid trail. G. Site of trail constructed in 1991.

Work In 1991: During the summer of 1991, USFS used BPA funding to complete a series of rehabilitation activities as interim measures. (Some of the 1991 work was accomplished in the gloryhole itself, and some at the sediment traps where runoff from the gloryhole **enters Newsome** Creek [Figure 38].) In addition, the Elk City Ranger District submitted a separate project proposal to the Northwest Power Planning Council. This proposal requested 1.3 million dollars for an architectural and design contract for a stabilization plan, for implementation of that plan, and for maintenance of the project upon its completion.

6. Water was not draining properly from the ditch on the bench near the upper portion of the gloryhole, and steep cutbanks above the bench had sluffed. A Kubota KH41 was used to reshape the channel area in a 45-meter test plot. One portion of the channel was lined with concrete. A second was underlaid by perforated pipe and then lined with concrete. A third section was armored with erosion control matting and rocks, and the last was lined with rocks alone. Straw bales were anchored with reinforcement rods in an area of slumping; the area was then lined with erosion control matting and rocks. The area disturbed by the construction was seeded, fertilized and mulched.

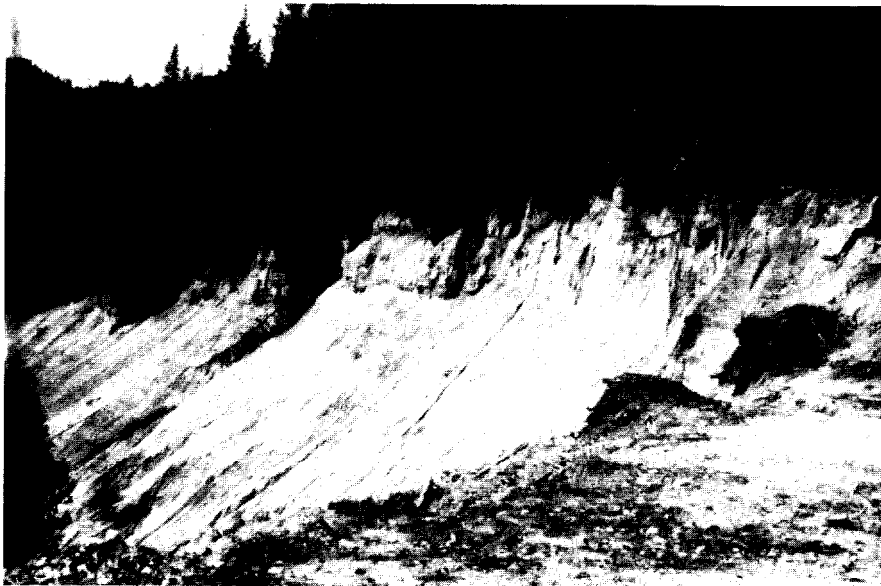
The Cal-Idaho gloryhole is located in Sec 28, T 29N, R 8E, on private ground surrounded by the Elk City Ranger District. Like many other gloryholes in the area, it was mined in the 1930s and 1940s; **water for the** original operation was brought from the Kirks Fork of the American River in a thirteen-kilometer ditch (Reed, 1934). The site is now approximately five hectares (13 acres), and contains bare slopes, vertical banks, gullies, springs, mudslides and partially-revegetated slopes (Figure 39). The soils are an alluvial deposit consisting mostly of a clayey-silt, intermixed with layers of gravel, clay, silt and some sand. The upper portion of the pit is much as the miners left it at a slope of some 100 percent (Figure 40). A local sawmill dumped mill waste down the slopes for several years in the early 1980s. The mill waste, composed of bark, dirt, rock and logs, is not highly erodible, and is generally staying in place. However, the material does not appear to be encouraging vegetative growth. Springs at the southwest corner of the gloryhole continually cause mudslides in that area.

Figure 40. Upper slopes of the Cal-Idaho Gloryhole, 1988.

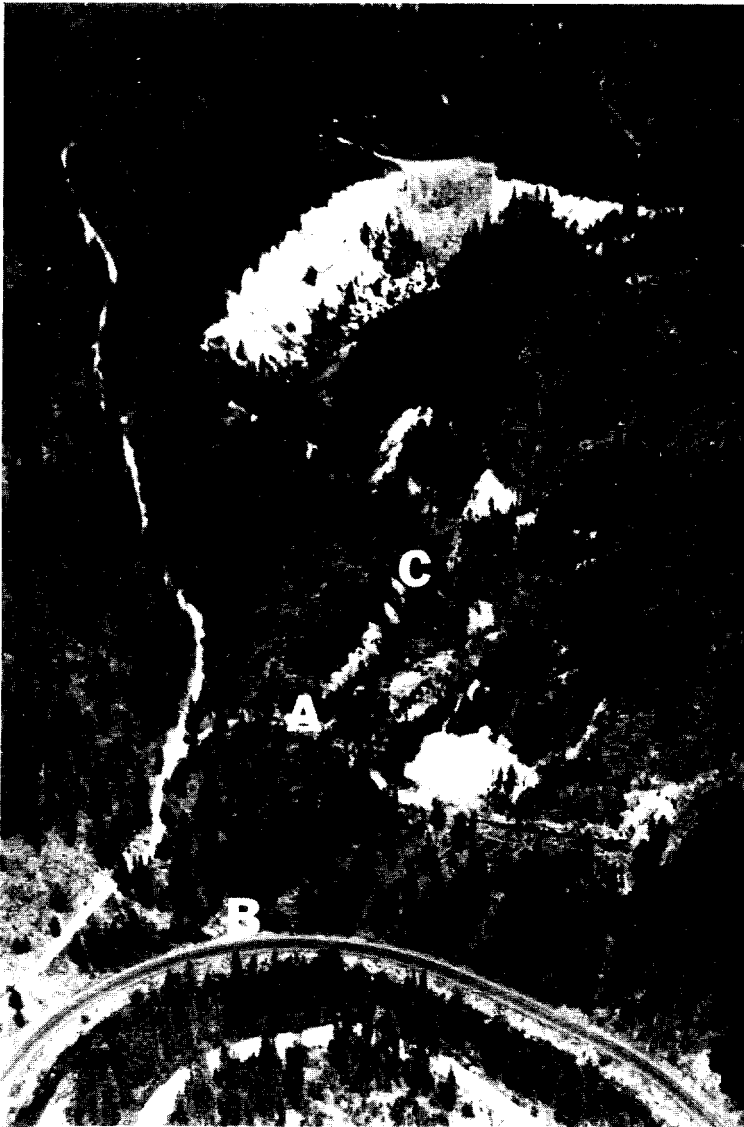
Figure 43. An aerial view of the Cal-Idaho Gloryhole.
A. Site of upper sediment trap (not constructed).
B. Site of lower sediment trap (not constructed).
C. Site of rock crib check dam constructed in 1990.
Photo courtesy of L.C. Hanson Company.

LC. Hanson Company's original design called for two sediment traps, one in the basin formed by a jeep trail just below the gloryhole, and a second in the basin formed by County Road 222, where runoff from the gloryhole is directed through a culvert (sites A and B, Figure 43). The upper trap would filter 80 percent of the runoff from the basin, and would have a storage capacity of 620 cubic meters. The lower trap would have a capacity of 987 cubic meters. These two traps, according to LC. Hanson, would provide three and a half years of storage, assuming a high sediment delivery of 356 tons a year (higher than the high estimate made by the Nez Perce Forest hydrologist), and a .78 tons/cubic meter conversion factor.

Unfortunately, objections from the landowner precluded the construction of this lower trap. The contract with L.C. Hanson was then revised to include design of a third sediment trap, a rock crib check dam, higher in the drainage than the first two (site C, Figure 43). This trap was to be constructed with treated timber and filled with dredge rock. Design plans for this structure are detailed in Figure 44. The landowner allowed construction of this third trap during the summer of 1990.

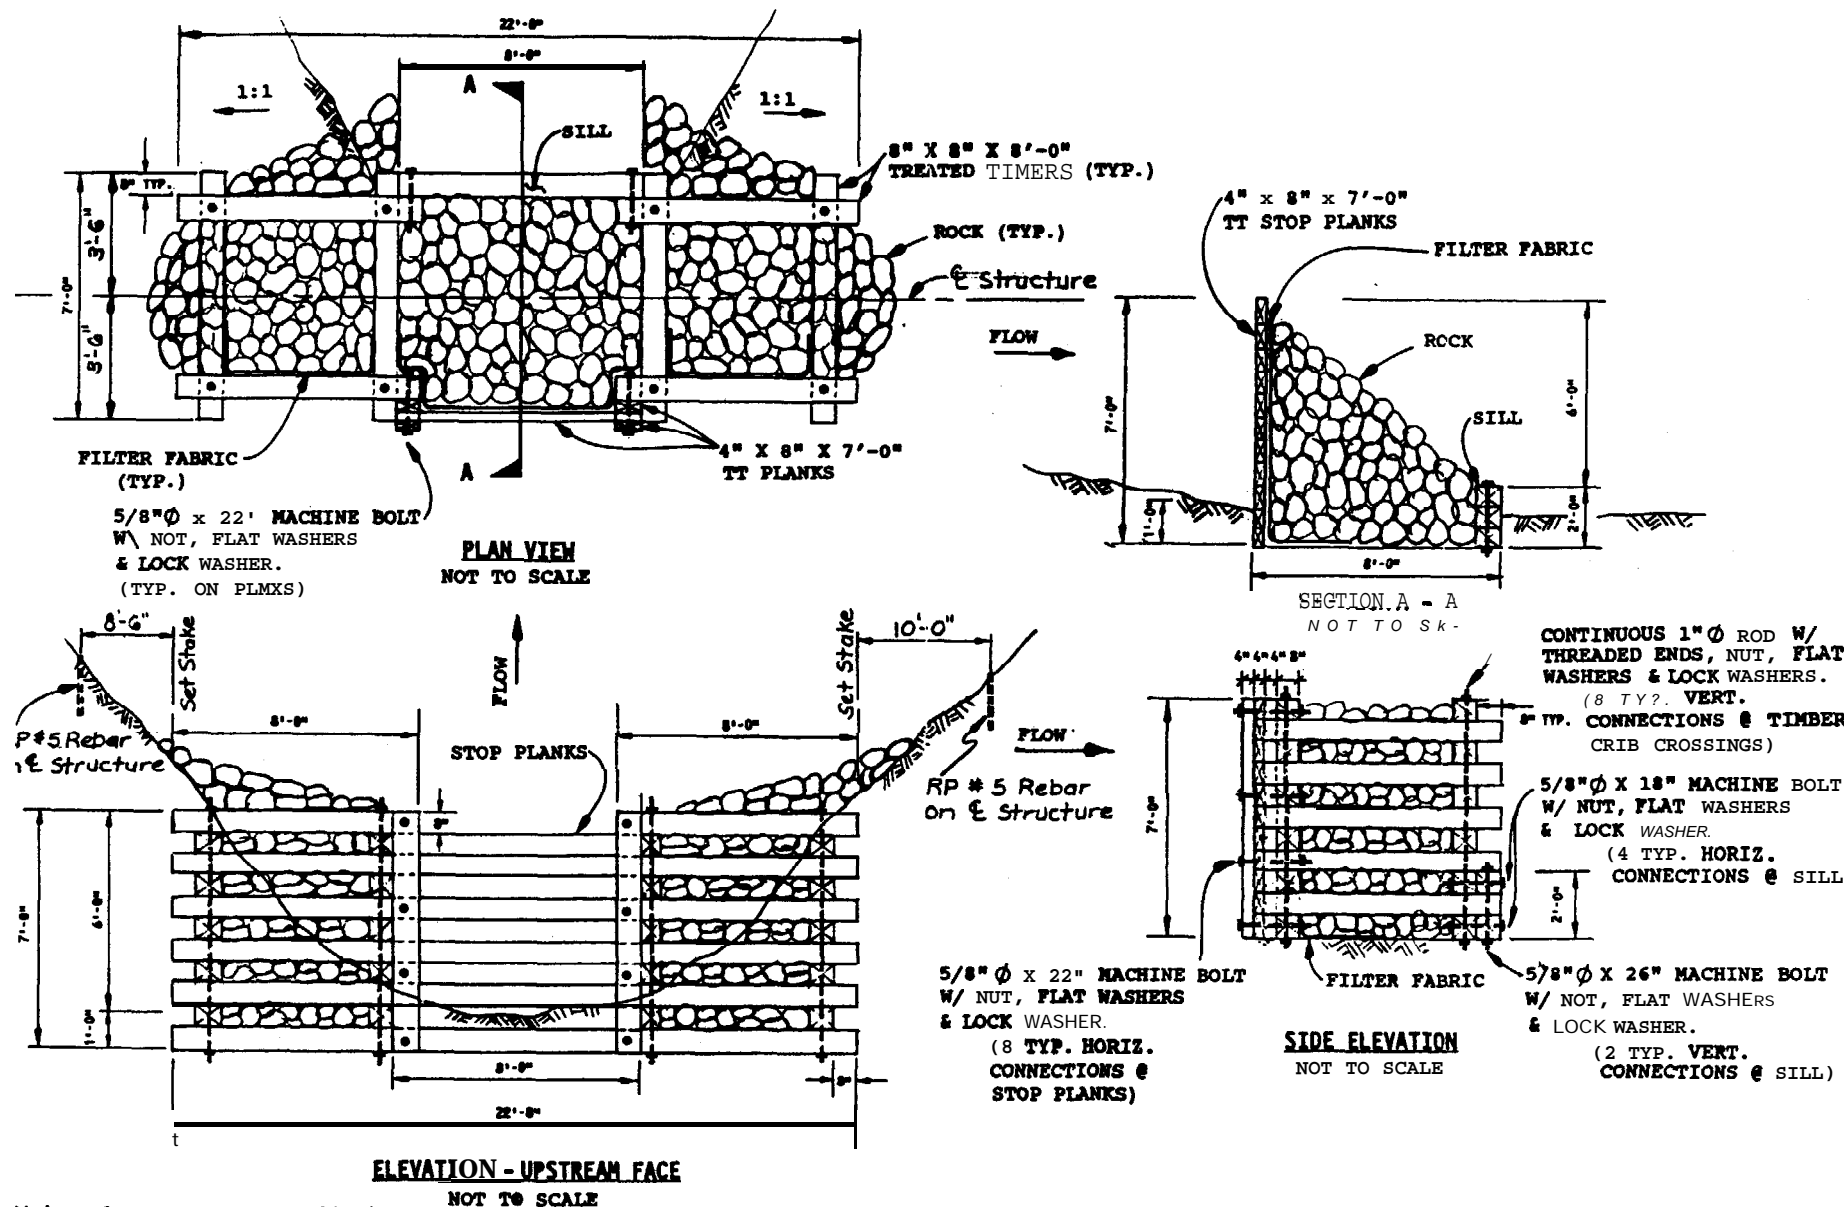
Figure 44. Contractor design of rock crib check dam constructed in Cal-Idaho Gloryhole, 1990.

- At the time of construction, two deviations from L.C. Hanson's plans (Figure 44) were made. While runoff is meant to filter through the dam walls, it was felt that two pipes through the center of the structure would help relieve pressure from water during times of high runoff (necessary until the structure settled) (Figure 46). As sediment levels approach them, the pipes will be capped to prevent sediment from passing directly through them. Second, because it appeared that water might flow around the edge of the structure, a 'wing' was constructed off one side and buried in the bank.

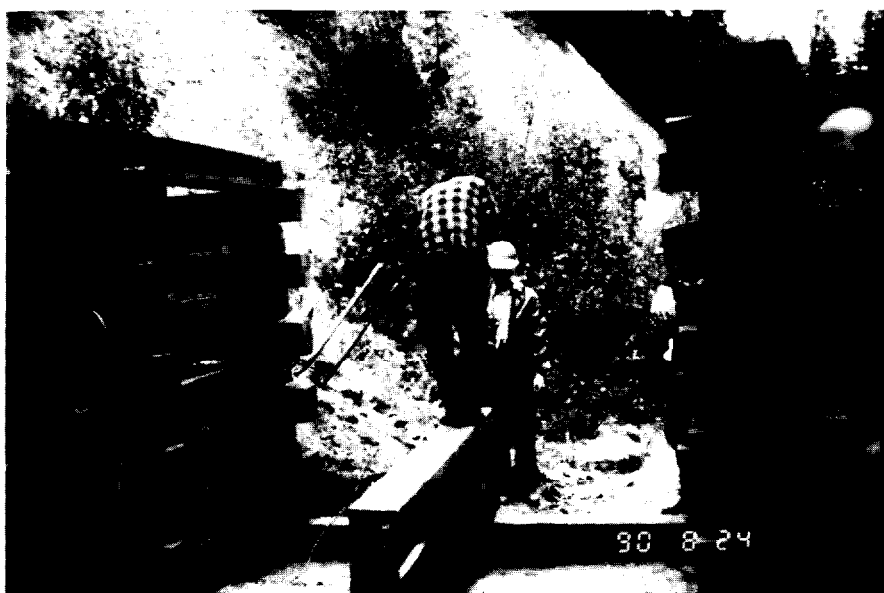
Figure 45. Constructing the rock-crib check dam in Cal-Idaho Gloryhole. 1990.

The sediment trap itself was built in the small canyon which drains the majority of the gloryhole. Because of the site's inaccessibility to machinery, all work was completed with hand labor (Figure 45). A crew averaging six members constructed the trap in roughly ten days. Once the crib framework was in place, a backhoe moved rocks from some minings tailings near the site to an area where the rocks could be hand loaded onto a conveyer belt. The conveyor belt, in conjunction with a wooden chute, helped to transport the rocks down into the cribs (Figure 46).

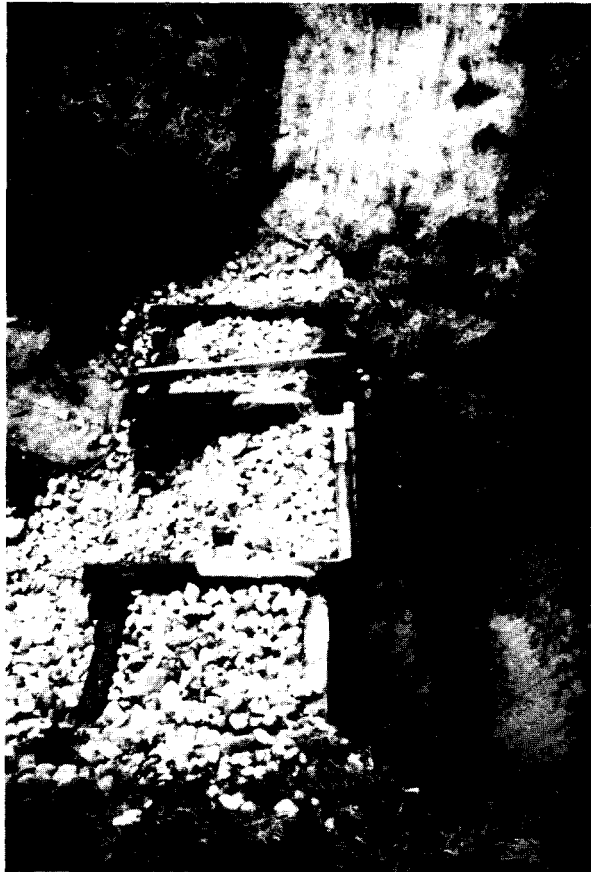
Figure 46. Partially completed rock-crib check dam at Cal-Idaho Glotyhole. 1990. Note drainage pipe in center of structure.

Early in 1991, two small leaks were noticed underneath and to one side of the the structure. In June, crews dug out several feet of fill adjacent to the structure **and** relined the area with a combination of filter cloth, bentonite clay, and clay from the site. In addition, crews added a wing to the side lacking one, and buried it into the bank.

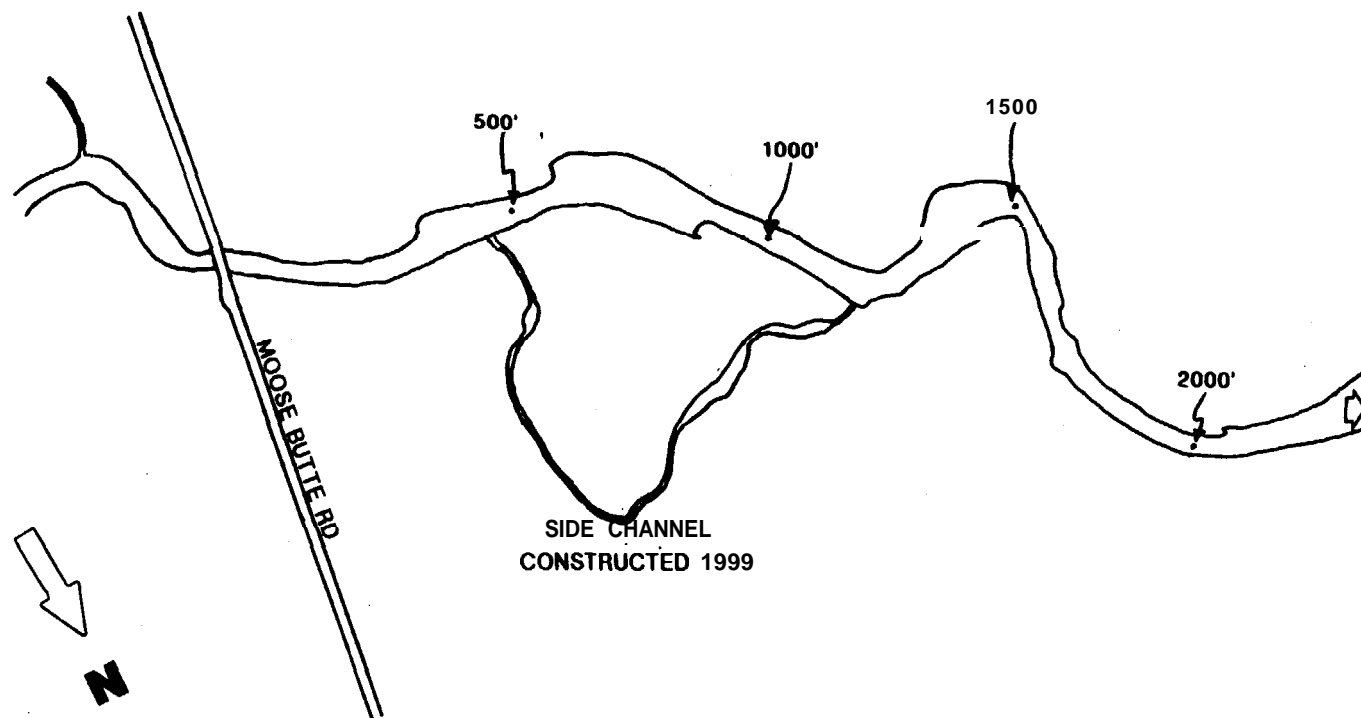
FIG 3

A sketch of the project reach is shown in Figure 3. In 1990, average width-depth ratio for 12 cross sections surveyed in a **1700-foot** reach downstream of the bridge was 44 (see Table 1). Meander lengths varied between 514 feet and 1015 feet, averaging about 840 feet. By comparison, meander lengths measured from the 1936 aerial photo averaged 448 feet. Radius of curvature ranged from 86 feet to 446 feet for the 2nd, 3rd and 4th bends below the bridge. In the same report, Rosgen also stated: 'Excessive bar deposition has shifted the velocity distribution to the near bank region and the higher width/depth ratio has reduced the shear stress necessary to move the sediment load of the river. The result is an accelerated sediment deposition and lateral channel adjustment.' Streambed sediment accumulation produced the uneven longitudinal profile shown in Figure 4. The aerial photo (Figure 2) shows the transverse bars that were present in the channel. These bars forced water against the outside banks in such a way as to cause excessive bank erosion, which was conservatively estimated to produce on the order of 300 tons or

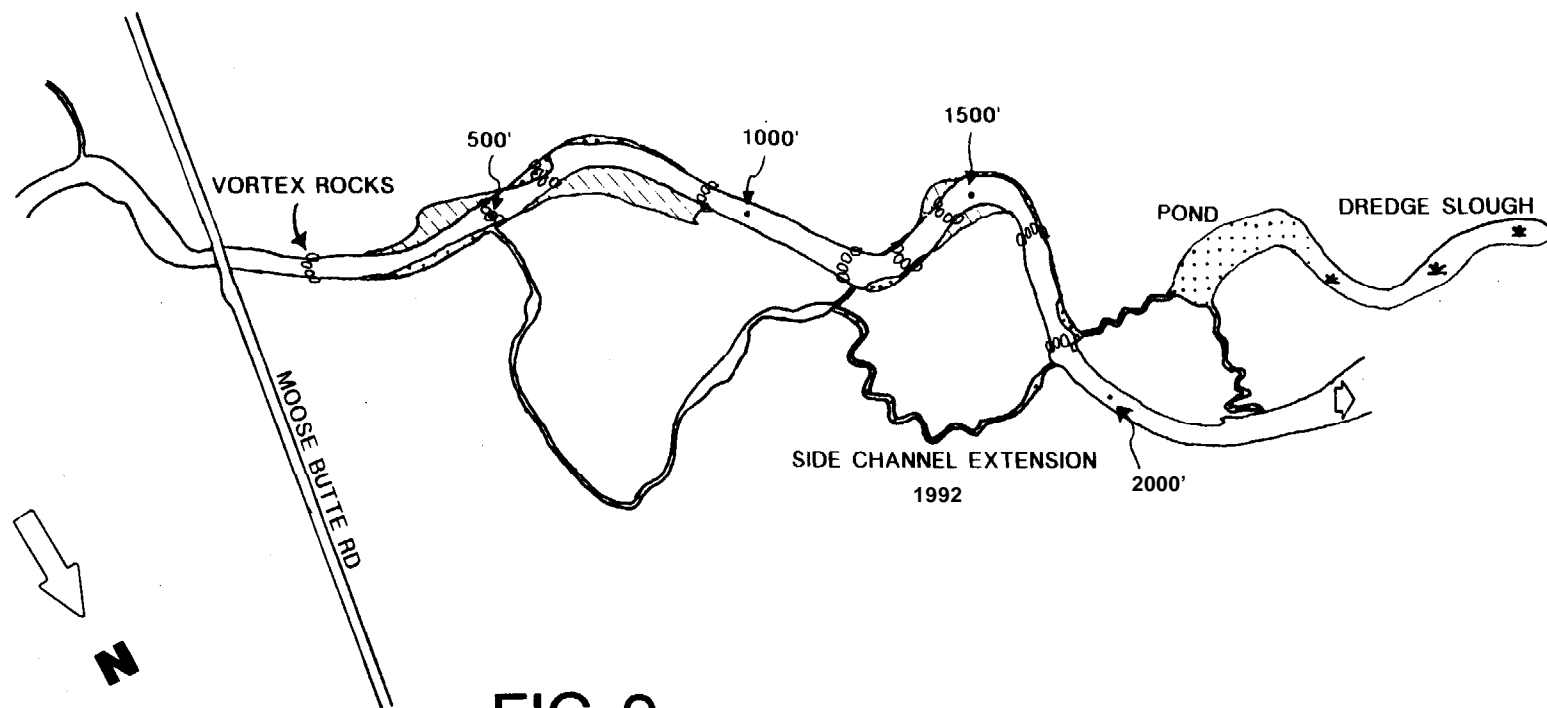
FIG 9

Figure 9 shows the post-reconstruction reach alignment, the rearing pond and the side channel that connects it to the river, and also identifies the areas that were excavated or filled. The upper side channel extension shown in this figure will be constructed in 1992. It will be an E4 channel about 1.5 feet wide and 1 to 1.5 feet deep and will include 2-3 rock grade controls near its outlet to the river.
